Nondestructive Examination of Glass-Reinforced-Plastic Rod End Fittings

April 1976

NBSIR 76-1084

NONDESTRUCTIVE EXAMINATION OF GLASS-REINFORCED-PLASTIC ROD END FITTINGS

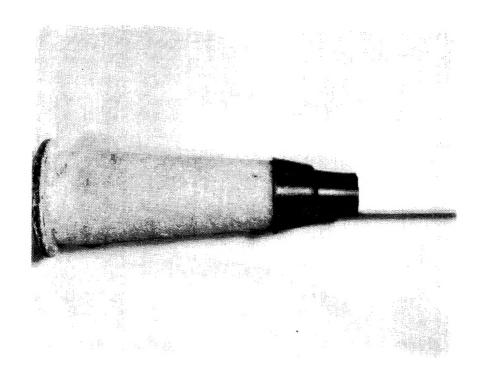
Figure 1 - Type 1 end fitting.

The Type 1 assembly, from the Loran station at Lampedusa, consisted of 17-mm (11/16-in) diameter, glass fiber-reinforced-polyester rod, terminated with potted compression end fittings. The Type 1 end fitting (Fig. 1) had a conical steel basket which is normally fitted with a metal yoke and bail (not shown in the figure) for attachment to thimble-and-eye hardware. A rubber boot covered the narrow end of the basket and the first few centimeters of rod where it emerged from the basket. Prior to potting, the end of the rod within the basket had been quartered and spread with a cruciform-shaped metal wedge similar to that shown in Figure 3. The basket was approximately 5 mm (3/16 in) thick at its thickest point.

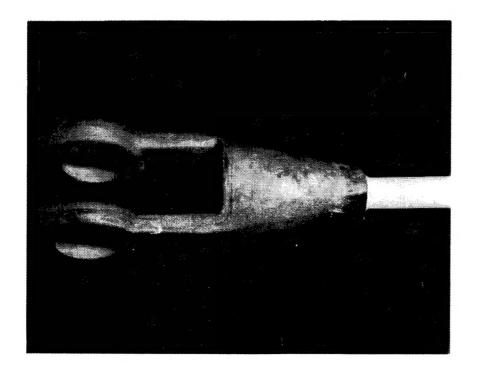
Figure 2 - Type 2 end fitting.

The Type 2 assembly, from the Loran station at Angissoq, consisted of 20-mm (25/32-in) diameter, glass fiber-reinforced-epoxy rod, terminated with potted compression end fittings. The Type 2 end fitting (Fig. 2) is also of steel, and is fabricated with integral clevises as shown in the figure. Conical metal wedges were used to spread the quartered rod ends prior to potting in these fittings. The wall of the basket part of the fitting measures approximately 11 mm (7/16 in) at its thickest part and 10 mm (3/8 in) near the tip of the wedge, the suspected area of trouble. See Figure 4.

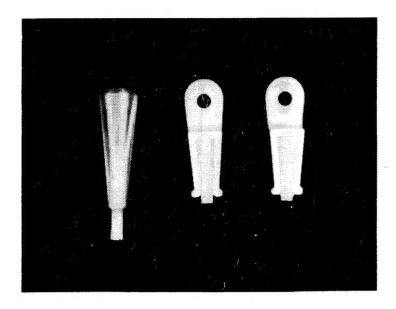
Due to the problems associated with the inspection of specimens with complex geometry, numerous interfaces, and material mismatches, two simpler but similar specimens (Fig. 5) were chosen for the initial feasibility study. The first was an aluminum end-fitting with a potted rod and no wedge. This end fitting was sectioned longitudinally and two short, transverse holes, 3.2 mm (1/8 in) in diameter, were drilled in the rod to serve as artificial defects. The second sample specimen consisted of a potted cone, containing a rod and wedge, removed from its metal end fitting.

Figure 5 - Left: Potted cone containing a wedged rod, removed from a compression end fitting. Center and right: Sectioned aluminum end fitting. Note the two small holes drilled into the rod in the center view.

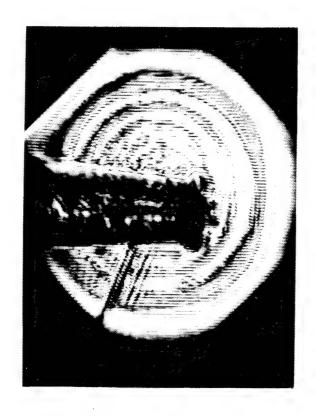
An ultrasonic hologram was made of the half of the split aluminum end fitting that contained the artificial defects. The test conditions were not necessarily optimized in this experiment and the result, as shown in Figure 7, is not completely satisfactory. Part geometry, material impedance mismatch, and inadequate system resolution were factors that limited the quality of this hologram. It is believed that better results for this

Figure 7 - Ultrasonic hologram of the sectioned aluminum end fitting. The end fitting is in the 9 o'clock position. The patterns in the light hexagonal background represent "noise".

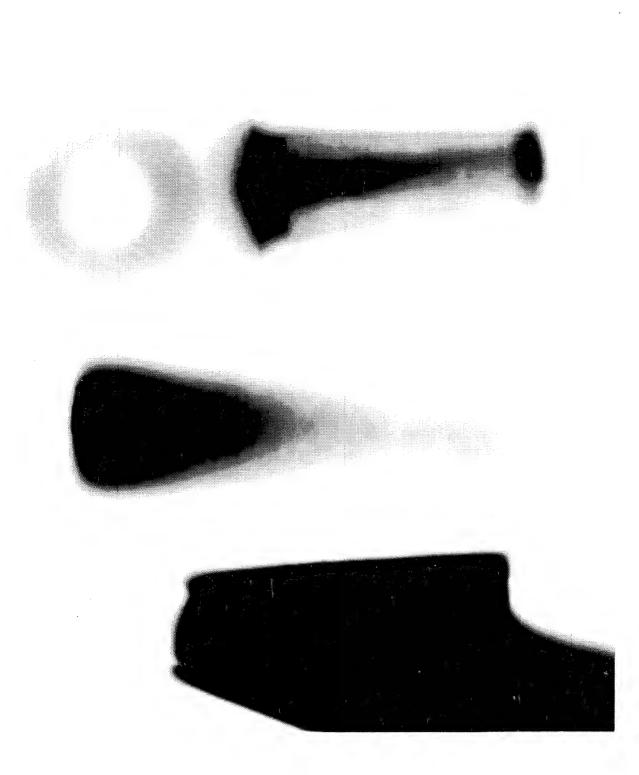
As many specimens as possible were radiographed simultaneously. Reasonably good results were achieved on the assembled sections of the aluminum specimen as shown in Figure 8. Fair results on the half of the sectioned Type 2 fitting (Fig. 9) and poor results on the Type 1 end fittings (Fig. 10) were produced.* A complete Type 2 end fitting was not penetrated. These results are considered to be of limited usefulness since aluminum end fittings were outside the intended scope of this investigation and the results on the Type 1 and Type 2 end fittings were unsatisfactory.

Figure 8 - Print of an X-radiograph showing reasonably good detail of the artificial defect in the aluminum end-fitting assembly (right). The detail is poor for one half of the Type 2 end fitting (left) and for the Type 1 end fitting (center).

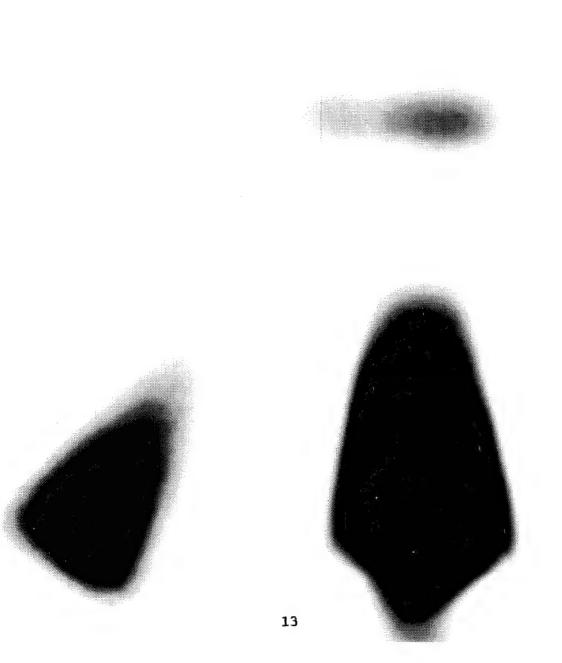
Figure 9 - Print of an X-radiograph showing fair detail of one half of a Type 2 end fitting (lower left). The detail is poor for complete Type 2 (upper left) and Type 1 (center) end fittings. The aluminum end fitting (right) is completely overexposed.

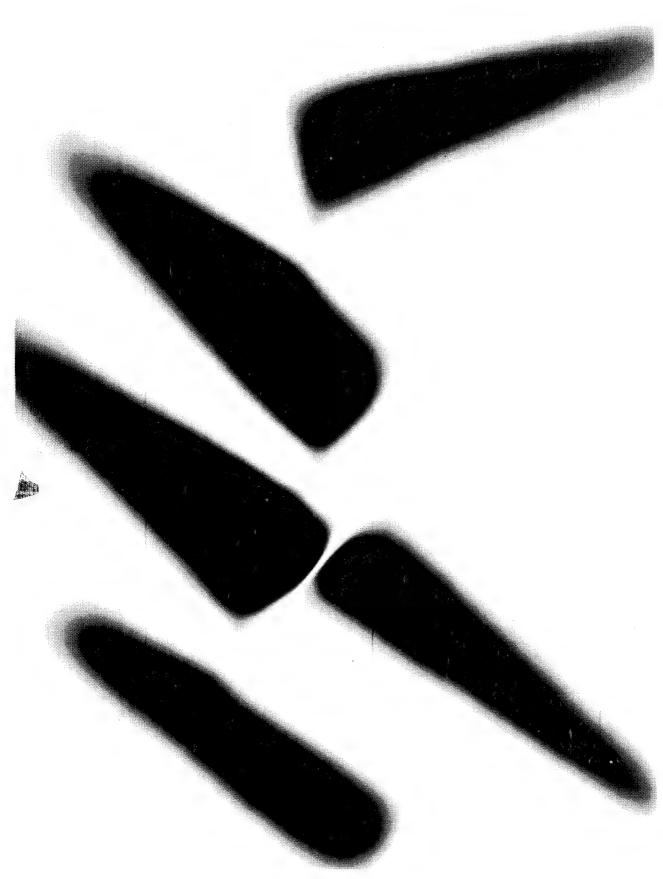
Figure 10 - Print of an X-radiograph showing faint traces of the cruciform wedges in Type 1 end fit-tings. The blank area (lower center) is a completely overexposed aluminum end fitting.

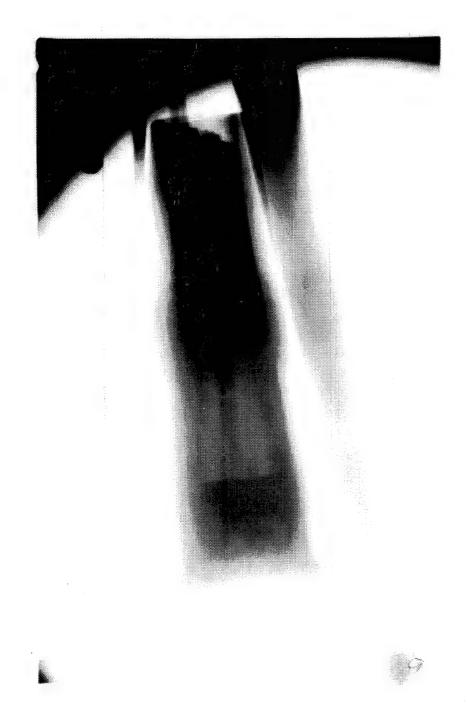
The use of the smaller aperture produced insufficient radiation levels for radiographs on the end fittings. Only radiographs using the 25-mm (1-in) aperture and Type AA film produced satisfactory results with a Type 1 end fitting. These results were significantly better than those obtained with x-ray techniques. For example, the tapered cruciform wedge of the Type 1 end fitting (Fig. 11) was well defined after a 10-minute exposure to thermal neutron radiation. But the conical wedge of the Type 2 end fitting (Fig. 12) was still not evident after a 15-minute exposure. At this exposure the Type 1 end fitting was slightly overexposed. Table 2 summarizes the conditions used to produce the thermal neutron radiographs.

Figure 11 - Print of a thermal neutron radiograph of a Type 1 end fitting showing the cruciform wedge and the fractured rod end.

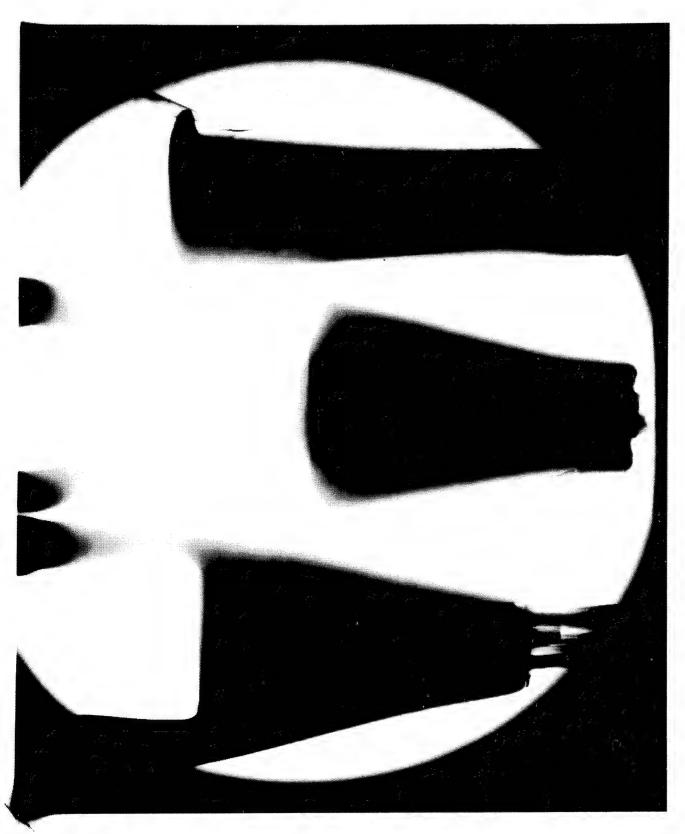
Figure 12 - Print of a thermal neutron radiograph of Type 2 end fittings (left and center) and a Type 1 end fitting (right).

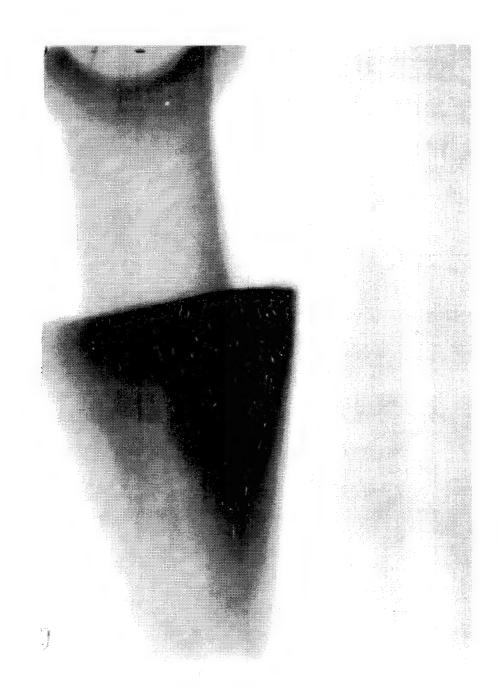
Figure 13 shows the results of a fast neutron radiograph of one-half of the sectioned Type 2 end fitting using Blue Brand film and a TL-2 film screen. These results are better than those obtained using x-rays, but results on half of a specimen are of little practical use. Figure 14 is a fast neutron radiograph of a complete Type 2 end fitting using RP/R type film and a TL-2 film screen. Only a faint definition of the interface between the steel fitting and the potting compound is visible. The conditions used to produce these radiographs are listed in Table 3.

Figure 13 - Print of a fast neutron radiograph of one half of the Type 2 end fitting. The gross defect at the tip of the wedge is faintly visible.

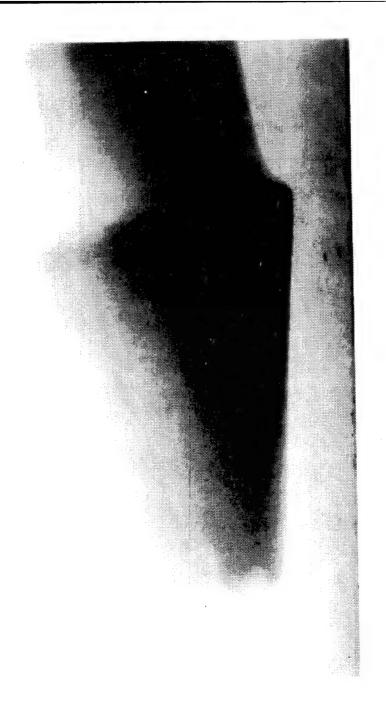
Figure 14 - Print of a fast neutron radiograph of a Type 2 end fitting showing poor definition.
